# **Lane Plating Works**

**City of Dallas Meeting  
March 21, 2017**

**U.S. EPA Region 6**

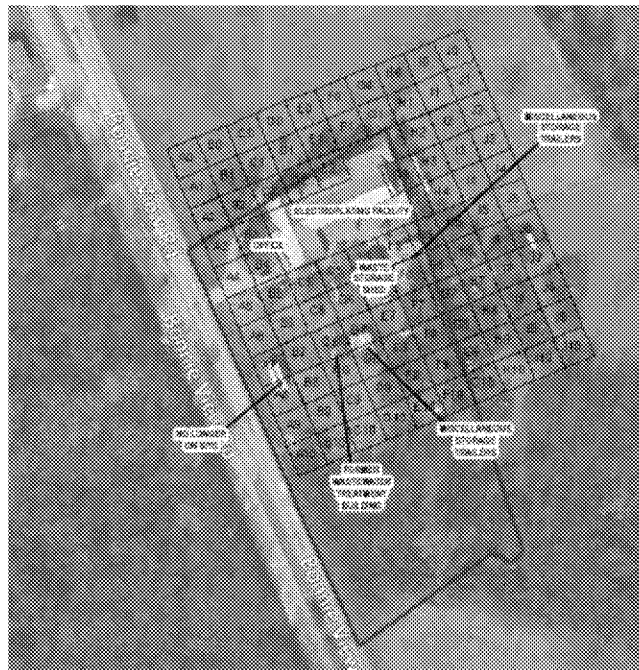
# Soil Sampling Grid

- ▶ Soil sampling conducted:
  - April 12 – 13, 2016 (initial Removal Assessment)
  - Sept. 19 – 23, 2016 (in conjunction with the Removal Action)

- ▶ Most common metals detected associated with Lane Plating operations:
  - Hexavalent chromium
  - Lead
  - Mercury

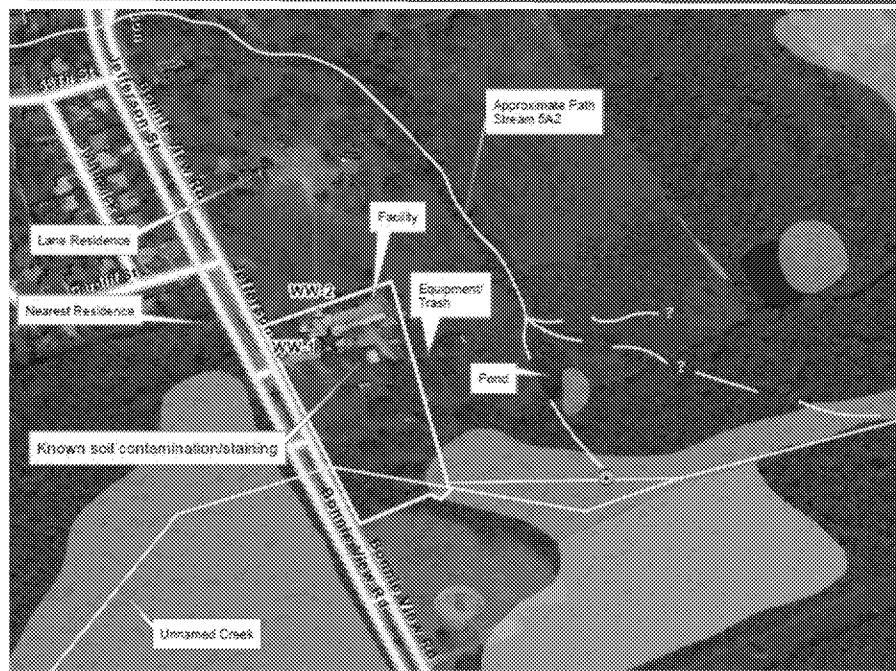
# SI Sampling Map

- ▶ Chromium, lead, and mercury detected in sediments collected from Surface Water Pathway
